Pacemaker endocarditis: approach for lead extraction in endocarditis with large vegetations

RBCCV 44205-1133

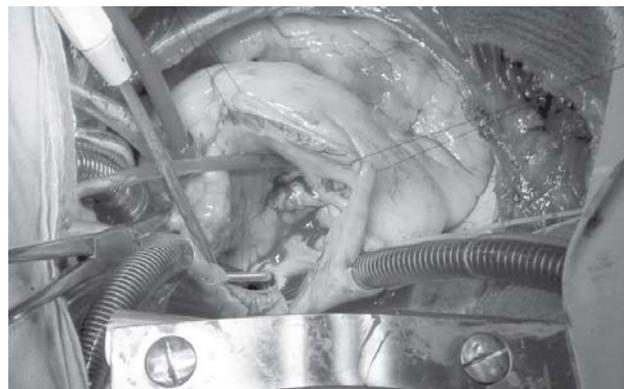
Fig. 1 - Note the location of the pacemaker ventricular lead crossing the interauricular septal defect

We decided pacemaker lead removal by surgical treatment due to the risk of obstruction to main stem of pulmonary artery. The electrodes were removed directly by sternotomy with cardiopulmonary bypass. This approach was decided on the basis of vegetations size. During surgery, simple pull back of the electrodes from the right atrium did not allowed the complete extraction, requiring a simultaneous percutaneous procedure. During surgery we corroborated that ventricular lead was placed on the left side of the heart through an atrial septal defect, closed with a patch of autologous pericardium (Figure 1).

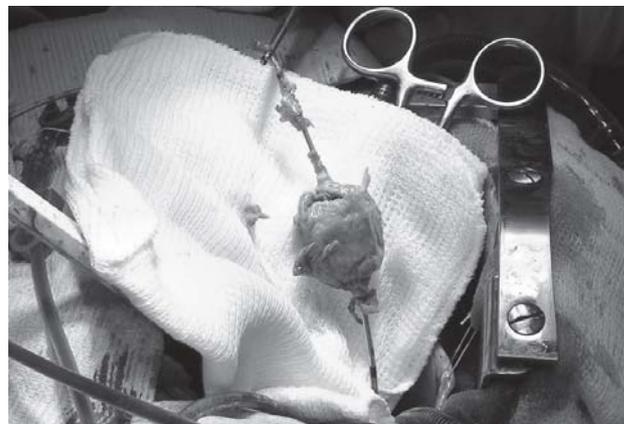
Fig. 2 - There is a large vegetation attached to the ventricular lead into the right atrium without affection of the tricuspid valve

In March 2005, she was admitted to hospital due to a new episode of fever and chills. TEE was performed and vegetation (40 x 9.7 mm) on pacemaker electrode was found. Laboratory data showed: hematocrit 30%, leucocytes 12700 g/l and acute renal failure which required hemodialysis. Four sets of blood culture were negative. Vancomycin and cefepime was started. Transvenous pacemaker lead removal was contraindicated in this case due to the size of the vegetation. A sternotomy with cardiopulmonary bypass was performed and the electrodes were extracted with a large vegetation (Figure 2), requiring a simultaneous percutaneous procedure because there were fibrotic adherences between the subclavian vein and the wires. Tricuspid valve was not affected. She needed vasoconstrictor drugs 24 hours after surgery due to vasoplegia. *Staphylococcus aureus* meticillin-sensitive growth from the cultures of the electrodes and vegetation were found.
