Endocardite em marca-passo: abordagem na extração do cabo-eletrodo em endocardite com grandes vegetações

Pacemaker endocarditis: approach for lead extraction in endocarditis with large vegetations

RBCCV 44205-1133

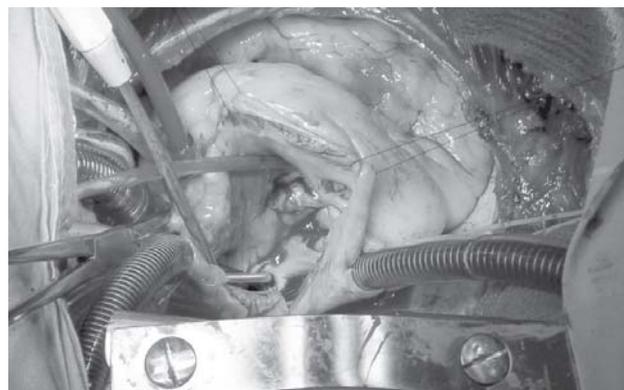
Fig. 1 - Note the localization of the pacemaker ventricular lead crossing the interauricular septal defect

We decided pacemaker lead removal by surgical treatment for the risk of obstruction to main stem of pulmonary artery. The electrodes were removed directly by sternotomy with extracorporeal circulation: This approach was decided on the basis of vegetations size. During surgery, simple pull back of the electrodes from the right atrium did not allowed the complete extraction, requiring a simultaneous percutaneous procedure. During surgery we corroborated that ventricular lead was placed on the left side of the heart through an atrial septal defect, closed with a patch of autologous pericardium (Figure 1).

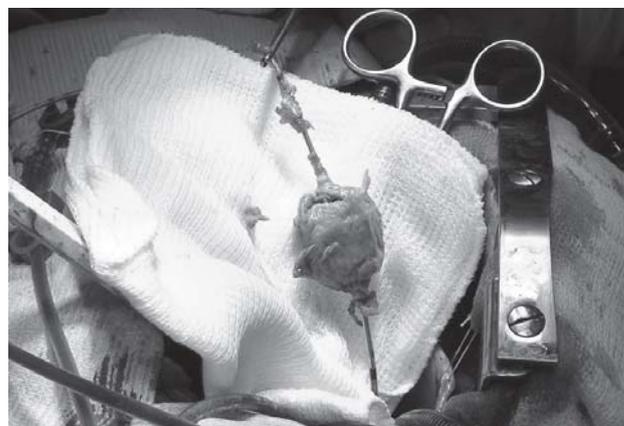
Fig. 2 - There is a large vegetation attached to the ventricular lead into the right atrium without affection of the tricuspid valve

In March 2005, she was hospitalized due to a new episode of fever and chills. TEE was performed and vegetation (40 x 9.7 mm) on pacemaker electrode was found. Laboratory data showed: hematocrit 30%, leucocytes 12700 g/l and acute renal failure which required hemodialysis. Four sets of blood culture were negative. Vancomycin and cefepime was started. Transvenous pacemaker lead removal was contraindicated in this case due to the size of the vegetation. A sternotomy with extracorporeal circulation was performed and the electrodes were extracted with a large vegetation (Figure 2), requiring a simultaneous percutaneous procedure because there were fibrotic adherences between the subclavian vein and the wires. Tricuspid valve was not affected. She needed vasoconstrictor drugs 24 hours after the surgery due vasoplegia. *Staphylococcus aureus* meticillin-sensitive growth from the cultures of the electrodes and vegetation.
